FRIENDSHIP FARM Kennedyville, Maryland (ca 1880)

INVENTORY FORM FOR STATE HISTORIC SITES SURVEY

K-370

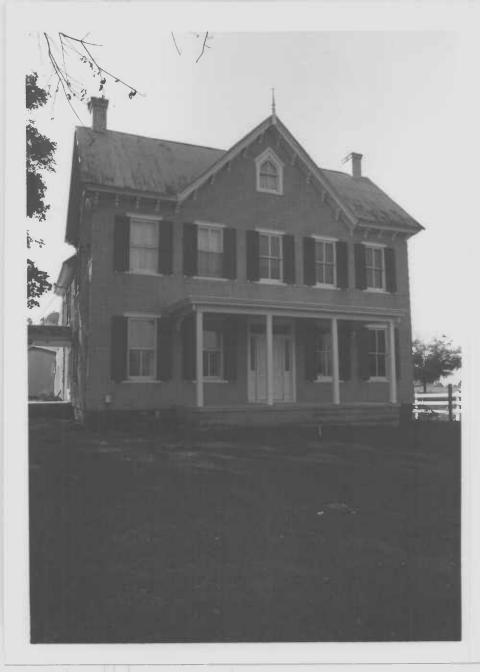
K-370 Friendship Farm toose North Facabe Kennedyville Kent County M.L. Fritz 11/1979

Friendship Farm House is a frame structure of the late 19th Century. It is a five bay, central-gable type house with a central entry leading to the main stair hall. The central gable of this building is wider than that of most buildings of this type; in this case it covers over three bays.

The gable roof of the main house is covered with tin roofing and finished with bracketted eaves; there is a cyma recta molding at the roof's edge and a turned finial atop the central gable. Brick chimneys with simple corbelled caps are located in each gable.
